The Impact of Hurricane Ivan on the Coastal Roads of Florida and Alabama: A Preliminary Report

Coastal Transportation Engineering Research & Education Center
University of South Alabama

September 30, 2004

Executive Summary

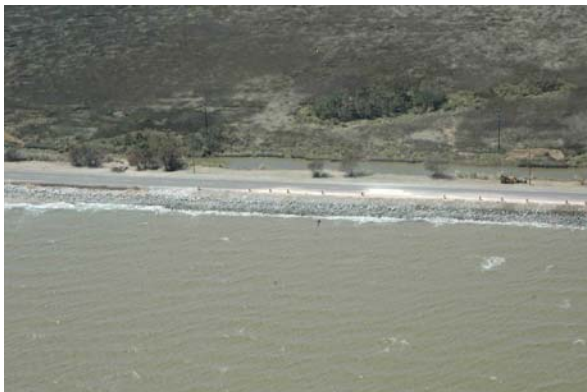
Photograph A. AL 193 revetment damage repairs. This damage was partly due to inadequate rock sizes for the storm waves.

Photograph A shows the on-going repair of a portion of AL 193, the causeway to Dauphin Island. It is the only access road. The photograph was taken five days after the storm and shows repairs to the northbound lanes that are behind a rock revetment. This revetment was built in 1999 after Hurricane Georges caused similar damage in this area. Ground inspection showed that some of the stones from the revetment washed across the road during Ivan. They were not large enough to withstand the waves from the strong winds from the east blowing across a fetch of up to 20 miles across Mobile Bay. A revetment a few miles north of this location at a county park designed using Hudson's Stability Equation (US Army Shore Protection Manual, 1984) fared much better in both Hurricane Ivan and Hurricane Georges (1998).

Another mechanism for damages was direct wave attack on revetment slopes (Photographs A, C, K, L). In this case damage appears to be partly due to inadequate armor layer design. Part of the problem is that the stones may be too small for the storm wave conditions. Attempts to make these slopes rigid with poured concrete also did not seem to work well (e.g. see foreground of Photograph N). Rigid revetments in coastal situations have a long history of undermining problems.

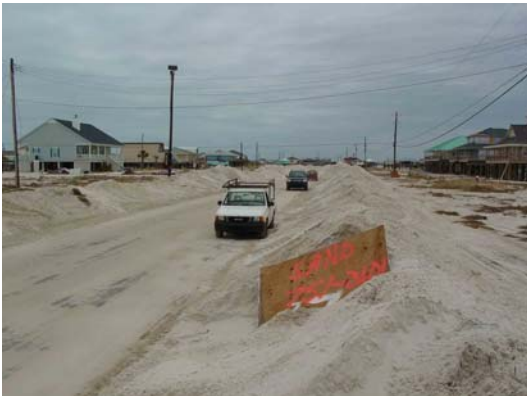
Photograph B shows sand piles that have been scraped off Bienville Boulevard on Dauphin Island, Alabama. This portion of this local road runs parallel to the coast about 500 feet back from the water. Portions of this pavement were washed out in Hurricane Georges in 1998 but not in Hurricane Ivan. The primary design difference is that after Georges, the road was rebuilt at the same elevation as the surrounding sand. Thus, there was no additional roadbed elevation for rainfall drainage (except a very slight crown). This intentional design decision appears to have worked very well during Ivan. The road was likely buried by overwash sand early in the storm and the pavement was essentially insulated from the highest velocities of waves and surge. This photograph is in stark contrast to many miles of roads that were damaged in Ivan elsewhere (e.g. see photographs D, G, H, J, Q, R of this report).

Photograph B. Bienville Blvd. was buried in sand during Ivan but the pavement was intact. Thus, the road was open immediately after sand removal. This intentional strategy, low elevation road construction, appears to have been successful at reducing pavement damages.

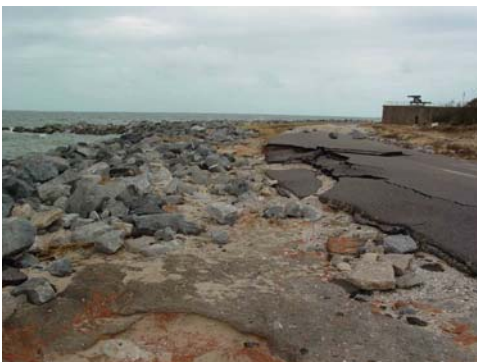
Photograph C shows damage to pavement on Bienville Boulevard at the eastern tip of Dauphin Island, Alabama. The pavement was fronted by a large seawall/revetment designed to protect the road and historic Ft. Gaines. This seawall was originally built in 1904 and was rebuilt in 1996. A few of the revetment stones moved across the road. This damage was due to waves from Ivan on top of the storm surge.

Photograph C. Pavement damage at eastern end of Dauphin Island, Alabama

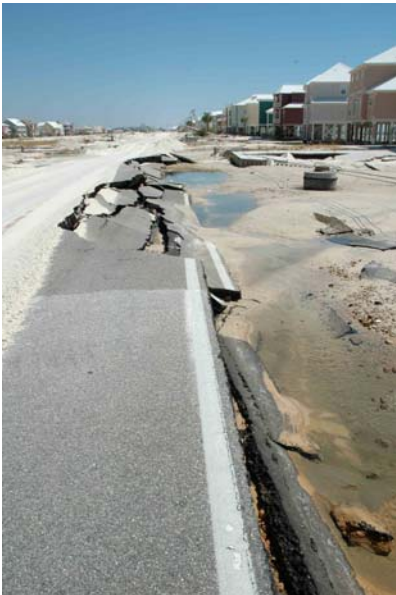
Photograph D shows damage to pavement on the south shoulder of AL 182 in Gulf Shores, Alabama. This portion of the road is locally known as West Beach Boulevard. It is on a barrier spit of sand between the Gulf of Mexico and a small bay called Little Lagoon. While this damage may have been caused by waves, it appears more likely that it was due to water flowing back out to the Gulf from Little Lagoon across the barrier spit later in the storm when the storm surge began to recede. It is possible that the roadway pavement was acting like a broad-crested weir and the sand on the south side was exposed to fast-flowing (super-critical flow into a hydraulic jump) water that scoured the sand as shown.

Photograph D. Pavement damage to AL 182 that was likely due to storm surge return flow.

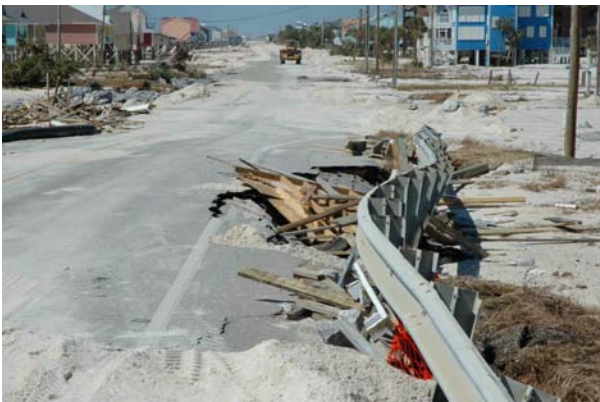
Photograph E shows some emergency repairs to damage to the approach to a small bridge on AL 182 over a very small tidal inlet, called Little Lagoon Pass, between Little Lagoon and the Gulf of Mexico. This photograph is of damage on the northwest side of the bridge looking west. There was damage on each side of both approaches. Similar damage was found on approaches to bridge abutments at other locations (e.g. see photographs N, O, and P of this report). These approaches are exposed to severe wave and current forces when storm surge raises the water level during hurricanes. These forces are probably much different and more severe than experienced by approaches to inland bridges during riverine flooding events.

Photograph E. AL 182 emergency repairs to damage to approach to Little Lagoon bridge.

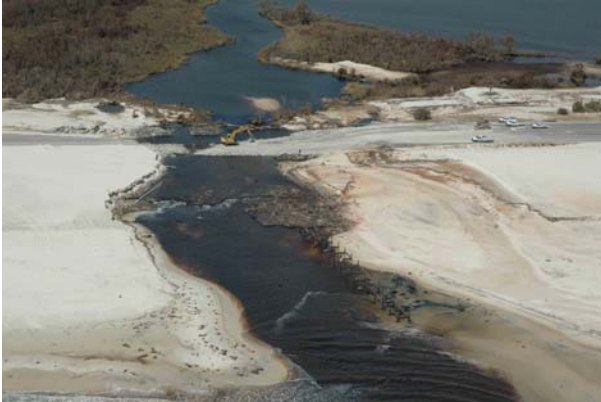
Photograph F shows emergency repair crews closing off a new inlet from a series of inland lakes (called Shelby Lakes) to the Gulf of Mexico. This photograph was taken five days after the storm. Similar breaches of the barrier island have occurred in this general area after other major hurricanes. The damage is due to a combination of surge, waves, and overwash raising the lake levels during the storm and then the water wanting to flow back out to the sea after the storm passes.

Photograph F. Ongoing repairs to breach in AL 182 at Shelby Lakes area.

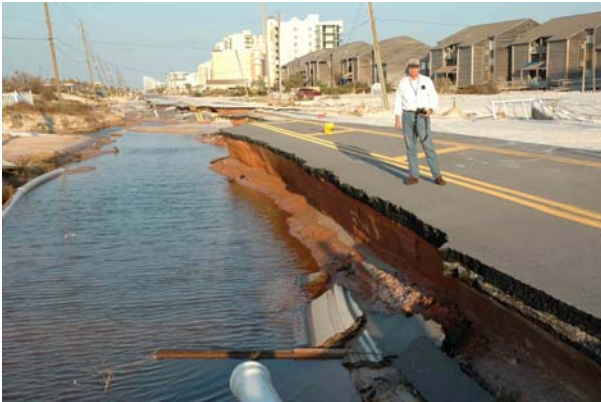
Photograph G. Pavement damage on north side of FL 292 due to "weir-like" flow down back side.

Photograph G shows pavement damage on the north side of a highway. This is FL 292 on Perdido Key very near the Alabama state line. It appears that the scour of the shoulder followed by scour of the underlying road base eventually undermines the pavement. The pavement then breaks off in blocks as its weight exceeds its internal adhesion. This type of damage was fairly common (e.g. see Photograph Q of this report). It had also been seen in several different locations around the country after other hurricanes.⁵ It is worth noting that the damage is on the side of the roadway away from the primary water body. The likely mechanism is water flowing across the road as the storm surge rises. The roadway pavement acts like a broad-crested weir and flow down the back shoulder of the

road is likely high-velocity, super-critical flow down to a hydraulic jump. The roadway is usually elevated above the adjacent ground and so it acts like a dam with the back side acting like a spillway. This scour mechanism may be exacerbated by broken waves periodically pumping water across the roadway. The velocity of the flow is clearly high enough under such a scenario for scour to occur on the unconsolidated and unvegetated shoulder. The University of South Alabama's Coastal Transportation Engineering Research and Education Center is planning to conduct laboratory investigations of this road damage mechanism in the coming year. These investigations are planned for both a large-scale river flume and a small-scale wave basin.

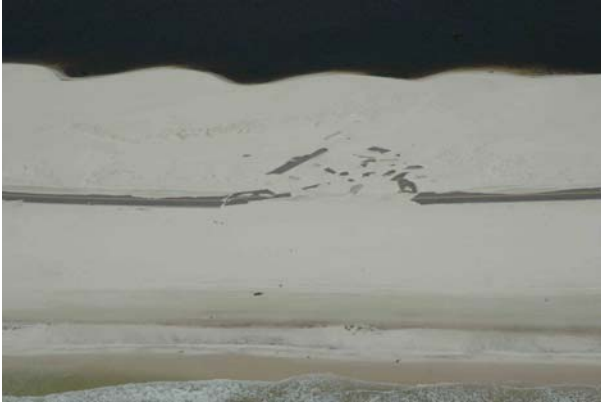
Photograph H. Pavement damage in Johnson Beach unit of Gulf Island National Seashore

Photograph H shows pavement moved north by Ivan. This damage occurred on a narrow, low barrier island spit that is part of the Johnson Beach unit of the Gulf Island National Seashore. The barrier island was probably several feet below sea level during the peak of the storm surge as large waves rolled across it. The photograph shows that sand was moved from the beach and dunes across the island and deposited in overwash fans on the north side of the island that extended into the back bay (Big Lagoon).

A fifth damage mechanism may have been the actual “floating” of pavement (Photograph H). This problem, due to the uplift pressures of high velocity flow and positive pore pressures, has been found on non-coastal roads subjected to flood flows. It may also have been a problem here in Ivan.

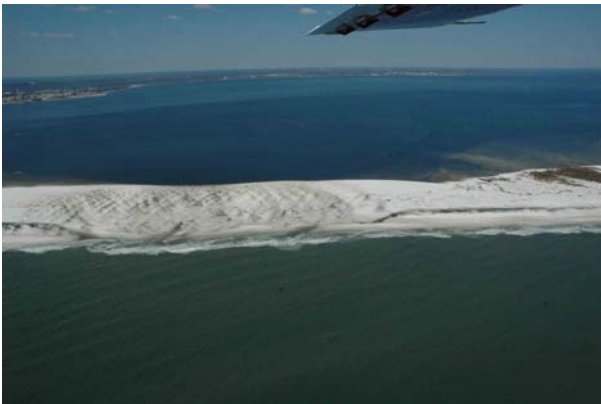
Photograph I. Ft. Pickens Road in Gulf Islands National Seashore damaged by overwash.

Photograph I shows a portion of an overwashed barrier island spit. The pavement was destroyed in a number of places similar to this one. The road is barely visible (look at the edges of the photo). This road is Ft. Pickens Road in the Gulf Islands National Seashore. The back bay here is the main body of Pensacola Bay and the barrier island has a very low elevation. This was a major overwash area.

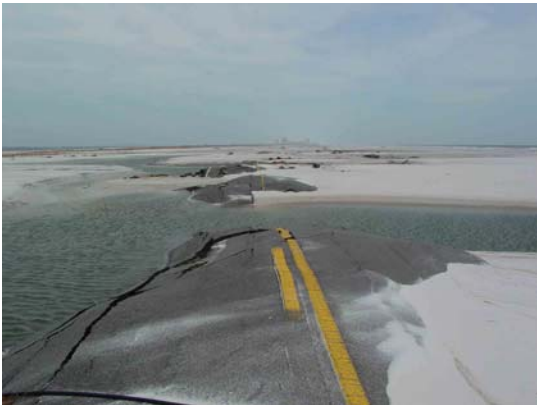
Photograph J shows pavement damage along Ft. Pickens Road in the Gulf Islands National Seashore. Similar damage was seen along miles of roadway throughout the Gulf Island National Seashore. In some locations, the pavement was moved across the barrier island. Broken pavement was found north of the former roadway in many places. Some pieces had been lifted and some had been flipped over. At other locations, broken pavement was found south of the former roadway. This damage was likely caused by a combination of the incoming and outgoing storm surge and the waves moving across the barrier island during the storm surge. In some locations, the pavement was not visible. Similar damage was experienced along most of these roads in Hurricane Opal (1995) and this roadway was rebuilt in 1996.

Photograph J. Pavement damage to Ft. Pickens Road in Gulf Islands National Seashore

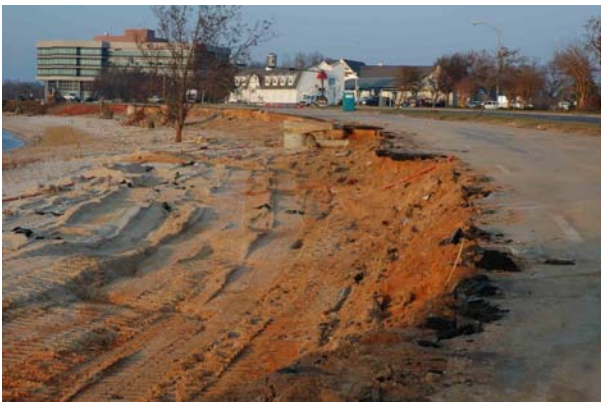
Photograph K shows damage to the pavement on the southeast-bound lanes of US 98 along the waterfront in Pensacola, Florida. Some emergency repairs were underway before the photograph was taken. This damage appears to be due to wave attack on the road embankment. Pensacola Bay is immediately to the left in the photograph. There was some bluff stabilization attempt here before the storm but it did not adequately protect the roadway from the waves on top of the storm surge.

Photograph K. US 98 pavement damage in Pensacola

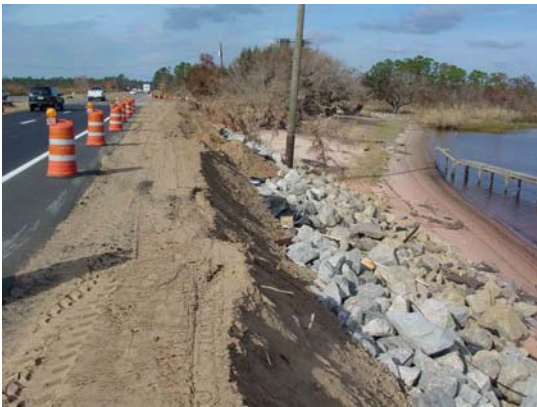
Photograph L shows repairs to the northeast bound lanes of US 90 along the waterfront at the north end of the Escambia Bay arm of Pensacola Bay. The photograph was taken 10 days after the storm. The emergency repairs appear to have included the reconstruction of the embankment and the pavement of both lanes. This road is now the main detour around the bridge collapse for passenger vehicles on Interstate-10. This damage was caused by wave-induced erosion at the storm surge levels. There appears to have been some limited form of shore protection prior to the storm but it did not adequately protect the roadway. Some preliminary analysis of the storm surge included in the next section of this report (Figure 2) indicates that this upper portion of the bay experienced extremely high surge as winds pushed the water up into this area. The waves in this area were also very large (Figure 3).

Photograph L. Repairs to damages to US 90 at north end of Escambia Bay arm of Pensacola Bay. Numerical simulations indicate that this end of the bay should have had the highest surge elevations and very large wave heights (up to 9 feet). The existing shore protection was not adequate to protect the road.

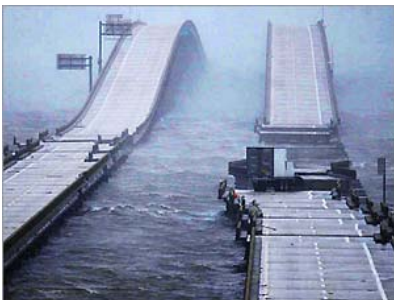
Photograph M. Interstate 10 bridge collapse into the Escambia Bay arm of Pensacola Bay (AP photo from web). This damage was from waves hitting the bridge decks due to the storm surge.

Photograph M shows damaged portions of the bridge deck of Interstate-10 crossing the Escambia Bay arm of Pensacola Bay. Sheppard and Renna⁶ have already investigated this damage and concluded that it is due to the waves and storm surge. The storm surge raised the mean water level to an elevation at or near the horizontal bridge spans. This allowed them to be exposed to large wave loadings. The waves would have brought much greater forces to bear on the spans than could be caused by the mean current due to the storm surge (This is confirmed by the hydrodynamic model results in the next section

of this report). The fact that the lower spans near the middle of the bay failed could be explained due to the higher waves that would be expected in the deeper depths farther from shore in this bay under extreme south-southeast winds (This is also preliminarily confirmed by wave modeling results in the next section of this report). There was also erosion behind the abutments at the east end of the I-10 bridge.

The bridge decks would have been subjected to loads that were near the critical loads to move them off the pile caps. Where the loads were slightly larger, the decks dropped. Where the loads were slightly smaller, the decks just moved. And where the loads were smaller, they did not move.

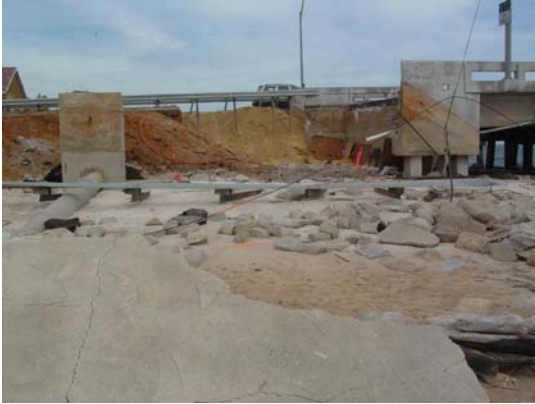
Photograph N. Damage to the approach to the bridge abutment at the north end of Bob Sykes Bridge on FL 399. Note that the entire two southbound lanes are destroyed for about twenty feet.

Photograph N shows damage to the approach to a bridge abutment for FL 399 as it approaches the north side of the Bob Sykes bridge between Gulf Breeze and Pensacola Beach. This picture was taken five days after the storm. The photograph shows the entire southbound lanes (two lanes plus bike path) removed. The repaired portion is actually the northbound lanes behind the missing southbound lanes. In Photograph N, the bridge was closed for emergency repairs which is why the vehicle is parked going the wrong direction. Close inspection of the photograph shows the pre-storm soil line on the bridge abutment (right side of photograph). The up-right concrete structure on the left side of the photograph is a drop inlet box for storm water runoff that was entirely below grade prior to the storm. This approach was protected by some form of revetment prior to the storm that failed to adequately protect the roadway.

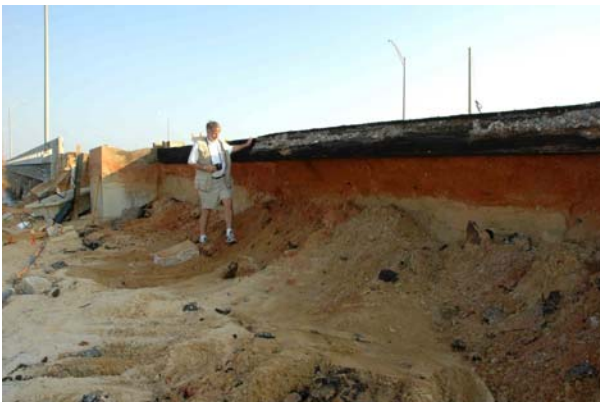
Photograph O. Wave damage to pavement on the approach at the south end of Bob Sykes Bridge, FL 399 in Pensacola Beach

Photograph O shows damage to the approach at the south end of the same bridge as shown in Photograph N. This type of damage was likely due to waves attacking the embankment on top of the elevated storm surge. This sort of damage to bridge

approaches during hurricanes is common. It has been seen after other hurricanes as well as in Photographs E, N, and P of this report.

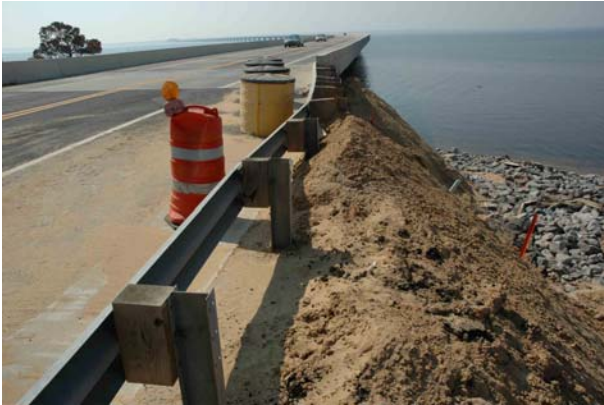
Photograph P. Repairs to damage at north end of Garcon Point Bridge

Photograph P also shows repairs to damage to an approach to the bridge abutment for Escambia County Road 191 at the north end of the southbound lanes of the Garcon Point Bridge across Pensacola Bay. This picture was taken eleven days after the storm. The repair shown indicates that a portion of one lane was damaged in the storm. A shore protection revetment failed to protect the roadway. This damage, like much of the damage to bridge approaches, was due to wave attack on top of the storm surge.

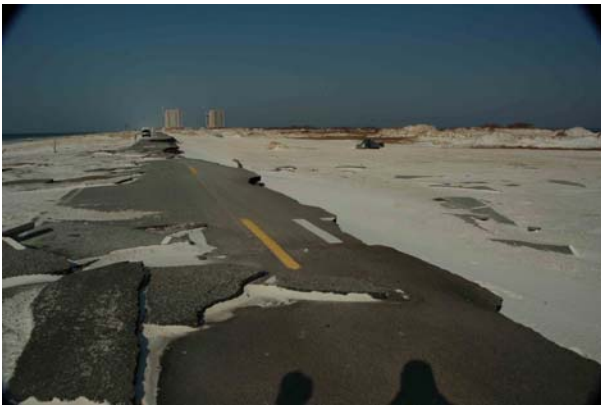
Photograph Q. Pavement damage to FL 399 east of Pensacola Beach.

Photograph Q shows roadway damage to FL 399 on Santa Rosa Island east of Pensacola Beach. This portion of the roadway was elevated over 10 feet above sea level. It was also built at a higher elevation than the sand immediately to the north. The indications are that this pavement damage was due to the weir flow mechanism (see discussion for Photograph G). The broken up pavement on the road in Photograph Q is from a parking lot that was south of the road behind where the picture was taken. The broken up pavement off to the right was from the road and from a bike path that paralleled the road. Immediately east of this location (50 yards behind the photographer), the elevation of the barrier island and the roadway dropped down about 5 feet. That lower portion of the roadway was completely destroyed (not shown).

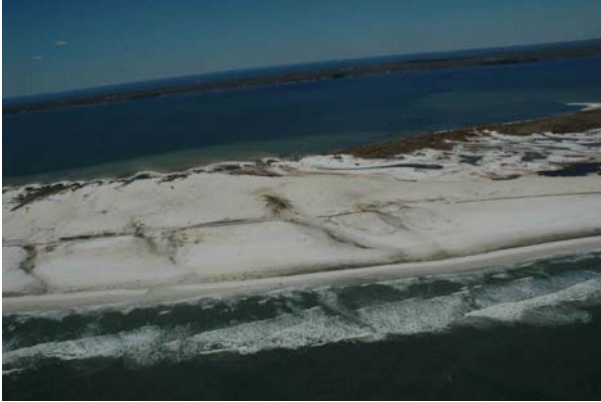
Photograph R. Damage to a portion of FL 399 in Gulf Islands National Seashore that had been relocated north to prevent such damage in 1996.

Photograph R shows a portion of FL 399 in the GINS that had been relocated farther north when it was rebuilt after Hurricane Opal (1995). This same portion had suffered limited pavement damage during Hurricane Georges (1998) and Tropical Storm Isadore (2002). The roadway was built on an overwash fan from Opal but was built elevated a few feet above the adjacent sand. Thus, unlike the road on Dauphin Island, Alabama shown in Photograph B, this road probably acted like a weir when the storm surge got to it instead of being buried by overwashing sand. From this photograph, it is not clear how much of the pavement is damaged and how much is buried in sand. Field investigations on the ground will be needed to determine the extent of the damage. Possible overwash channels with evidence for both northward and southward flowing currents are seen.

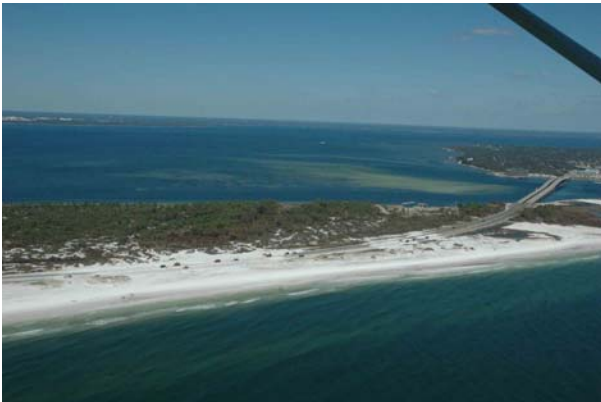
Photograph S shows repair underway on US 98 west of the bridge to Destin, Florida. This picture was taken the fifth day after the storm. It appears that this portion of the road may have suffered under direct wave attack.

Photograph S. Repairs underway on US 98 west of the East Pass Bridge.

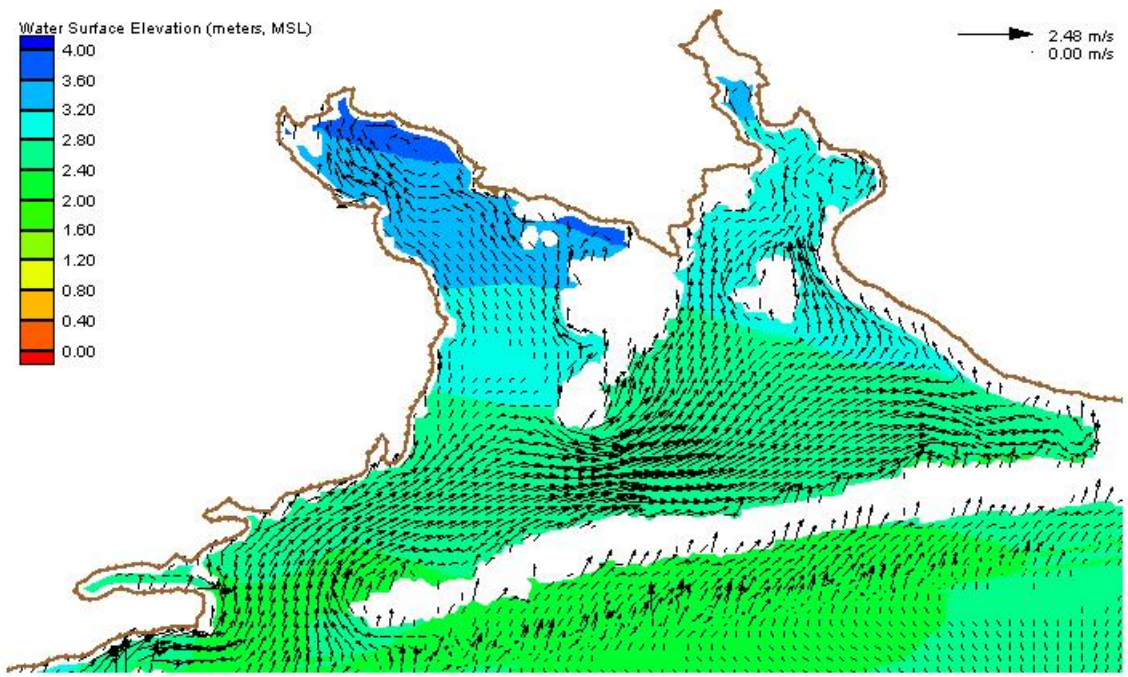
Figure 2 presents some preliminary, numerical storm surge modeling results for Hurricane Ivan. Pensacola Bay including Escambia Bay (the northwest arm) is modeled. The mean water surface elevation at the peak of the surge is shown. The location of the damaged portion of US 90 in Photograph L is in the darkest blue portion of the figure (the modeled floodplain extends over land). Thus, this analysis indicates that this portion of the roadway experienced some of the highest storm surges in Ivan.

The Interstate-10 bridge is located in the blue area of Figure 2. This high surge in the north end of Escambia Bay was partially caused by wind setup within the bay due to the extreme sustained winds blowing up the length of the bay. The hydrodynamic model is ADCIRC. These results are preliminary and subject to refinement and possible change. The record of the Pensacola tide gauge was used as the boundary condition and the measured average winds from the Pensacola airport were applied. The concept that the upper end of this bay experienced extremely high surges was also mentioned by Sheppard and Renna (2004). These preliminary model results indicate that the mean water level due to the surge could have been roughly 3.2 m (10½ feet) higher than normal. This would have placed the water level roughly even with the bottom of the bridge spans and thus exposed the spans to the maximum possible wave-induced lateral and uplift loads.

Figure 2. Estimated storm surge elevations in Pensacola Bay during Hurricane Ivan

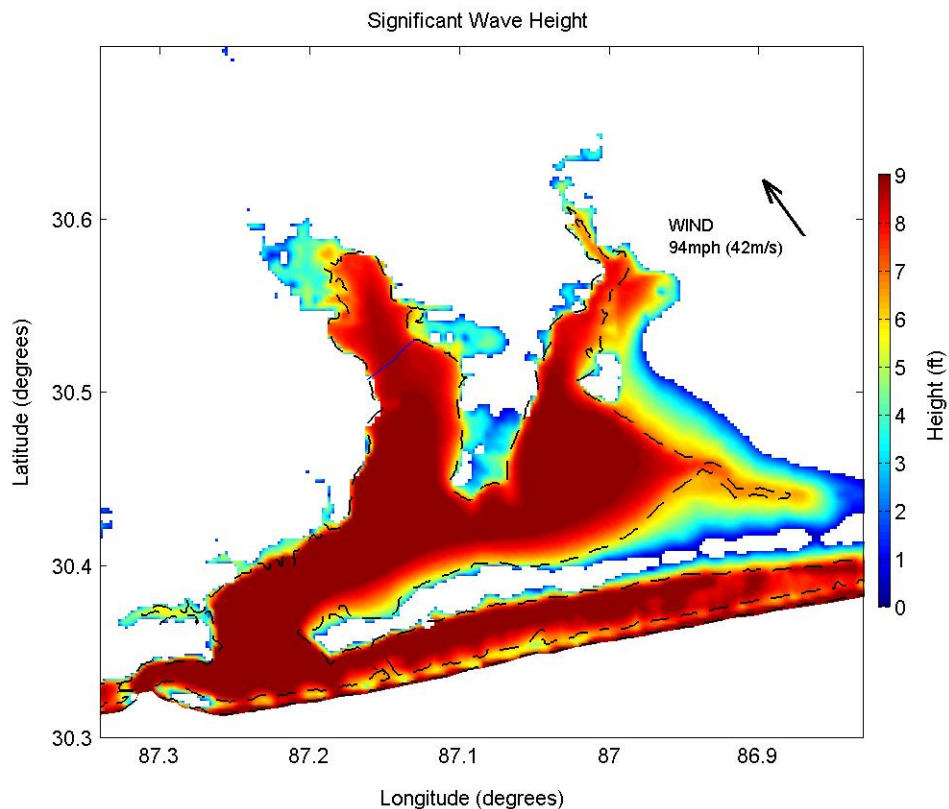
Figure 3 presents some preliminary, numerical wave model results for the area. The wave model is SWAN. The significant wave height in the vicinity of the bridge exceeds 9 feet. Many individual waves will exceed this height in such a sea-state. These results are large enough to cause excessive lateral and uplift wave loads on a rigid bridge deck. Also, the variation of wave height across the bay at the location of the bridge (line across Escambia Bay arm) indicates that the waves were highest in the middle of the bay. This is consistent with the failures shown in Photograph M.

Figure 3. Estimated wave heights in Pensacola Bay during Hurricane Ivan (the I-10 bridge is shown as the line across the northwest arm of the bay).
