ARMORED DITCH DEGRADATION AND ISSUES WITH EROSION

Cody Morris, Department of Earth Sciences, University of South Alabama, Mobile AL, 36688. E-mail: csm805@jagmail.southalabama.edu.

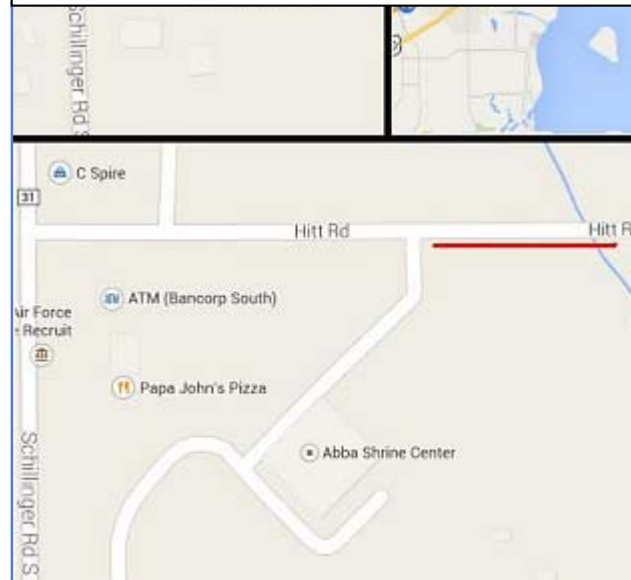
The concrete ditch was examined very closely, at least half of its length. It was discovered that the damage along most of the ditch was fairly minor. Most of this ditch's problems were from small cracks, possibly caused by concrete expanding. The most severe cracks had almost been “lifted” up, but each crack the ditch had was only horizontal. No sections were broken off, and the lifted up cracks were usually stuffed with leaves, leaving little sediment accumulation. This ditch was deeper than the bare ditch, but the concrete kept it from eroding any more. During a heavy rain, water possibly just shot underneath the concrete, and was assumed to have caused erosion under the ditch. For most of the ditch's length, these were the only problems.

If the small horizontal cracks were the only problems the broken armored ditch had, this ditch would have had even less examples of erosion than the heavily vegetated ditch. This was not the case however. About half way along the length of the ditch, where the armor merged with a concrete drain, there was a huge problem. The armor where the drain came out into a pipe had been dug out from erosion. Water had eroded around the concrete, then continued to erode until this formed a massive scoop. Although the exact size wasn't measured, the scoop was large enough for a person to crawl inside.

The only thing put in place to help stop the erosion was a small cluster of rip rap stones. Based off the still huge size of the scoop, the rip rap wasn't stopping erosion well. The stream that followed the drain was filled with sediment, possibly sediment eroded from the scoop. Rip rap was laid down heavily in this area, but sediment was still accumulating. To compare all the ditches, the bare ditch was eroded, but not nearly as bad as this. The ditch filled with vegetation also did not have erosional problems as bad as either the bare ditch or the concrete section.

This research showed that problems like this that are ignored can be just as bad, or worse, than simple ditch erosion. If the ditch was not armored, the erosion would not have been as severe. It is unknown if the city knows about these problems, but the erosion underneath the concrete scoop was so bad it could possibly cause the concrete to fail and break off completely in the future. When ditches are armored in this way they increase stream flow. This causes any problems, like the scoop that was found, to erode faster than without concrete. Because of this, the city needs to become active in finding these problems and attempt to repair them.
