LAND DEVELOPMENT AND ITS AFFECT ON WATER QUALITY IN HALLS MILL CREEK

Chris L. Murphy, Department of Earth Sciences, University of South Alabama, Mobile, AL 36688. E-mail: clm404@jaguar1.usouthal.edu.

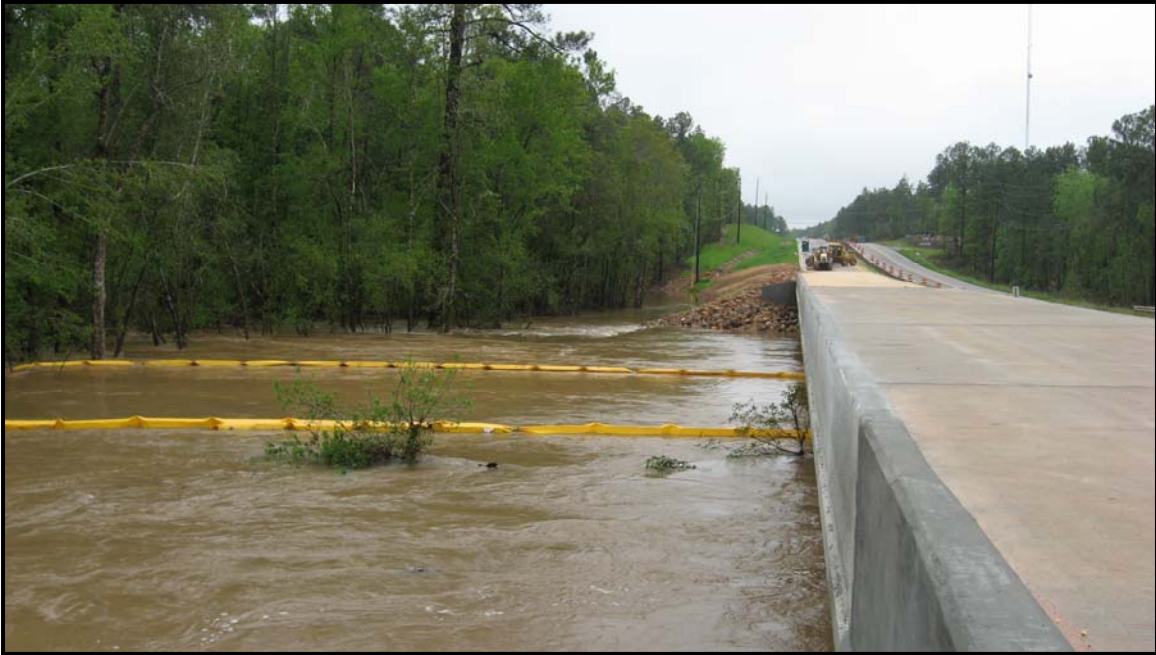
In my opinion, the reason for such low levels of change was the proper use of BMP's. The construction site had silt fences lined in all areas vulnerable to runoff. On top of that, stone channels were designed that fed storm water into the creek. These channels were also designed with stone damns to allow sediment to settle in its pools. Brush barriers were placed in front of all drain inlets, erosion cloth and/or fresh sod was placed on all slopes. A large sediment boom (shown on the following page) was also in place under the bridge on Hillcrest Road that crosses over the creek. Most importantly, all

Figure 5: Sediment Boom in Halls Mill Creek on 4/5/2008

of them were properly maintained and resistant to breakdowns after intense rainfall events. Other small factors could have played a role in the turbidity levels acquired. For instance, more vegetation downstream could clean the creek and cause the levels to lower, but this is unlikely the case. I chose my testing sites carefully according to their environment for that specific purpose.
