FOLLOW-UP ON CHANNELIZATION IN SPRING CREEK SUB-WATERSHED

Justin R. Beebe, Department of Earth Sciences, University of South Alabama, Mobile, AL 36688. jrb308@jaguar1.usouthal.edu.

Keyword: Channelization, Spring Creek, Gabion

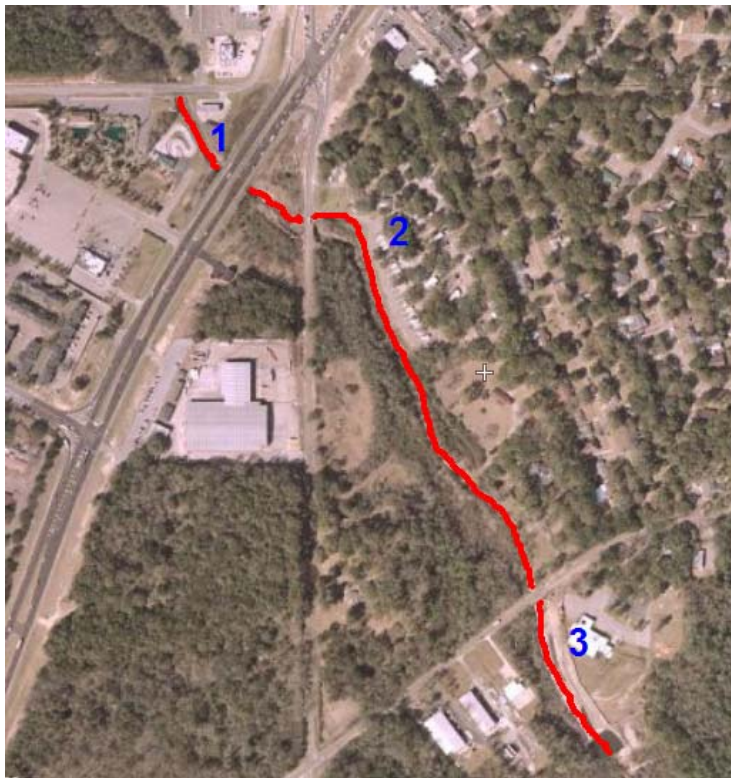
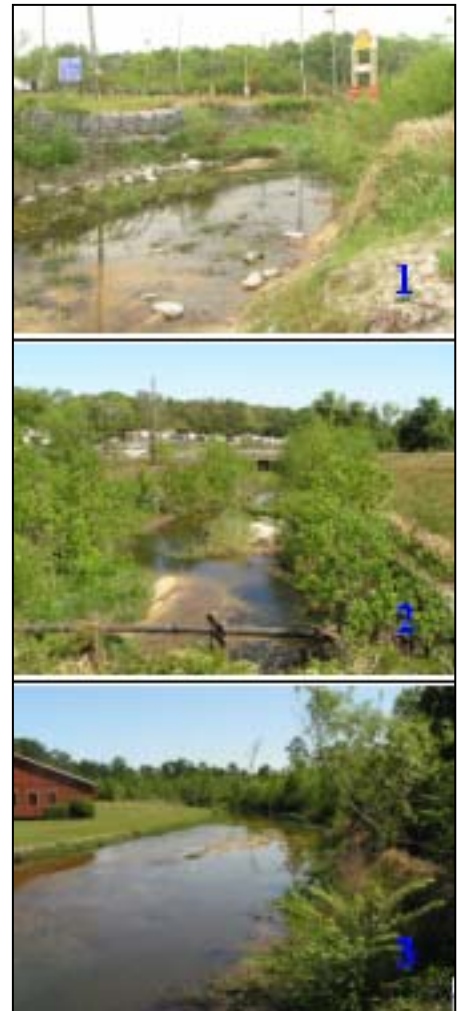
Figure 1. Spring Creek with markers at Section 1, 2 and 3.

In order to determine any change in sedimentation, the use of before and after photographs at portions of Spring Creek were used. Field reconnaissance to Spring Creek was also helpful in determining change since the project end in 2002. I broke down the area of construction into three parts so that I could analyze recorded data better. The first part of the Spring Creek construction was labeled section 1, it is found between Girby Road, and Highway 90. Section 2 of the creek was then labeled from the area running between Highway 90 and Halls Mill Road. Section 3 was labeled as the area south of Halls Mill Road beside the property of Two Dollar Bills Restaurant (Figure 1).

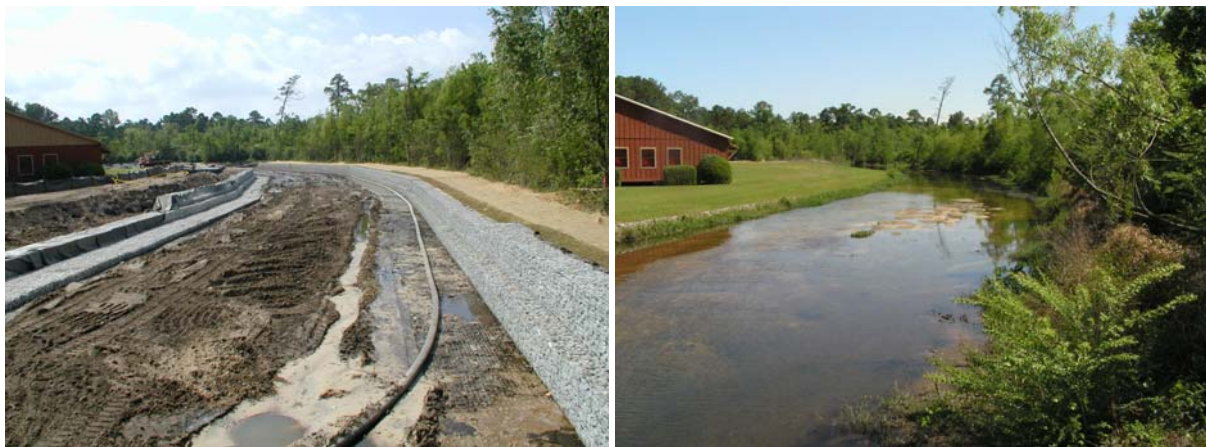
Figure 2 During and after pictures of Spring Creek at section three.

The data collected was recorded and summarized in Table 1 below. Sedimentation in section one totaled 5 ft, while section two totaled 5.5 ft. Section three totaled 4 ft. The total approximate deposition for each section was then averaged. I found that sedimentation occurring in Spring Creek after construction has averaged 4 feet 10 inches in the span of 5 years. The average depth of gabion construction was 9 feet. Photo-interpretive analysis also shows that sedimentation has occurred, and can give the observer an idea of change over time (Figures 2,3,4).

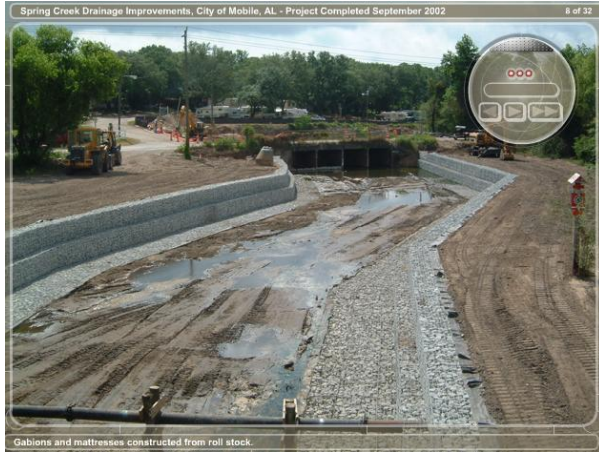
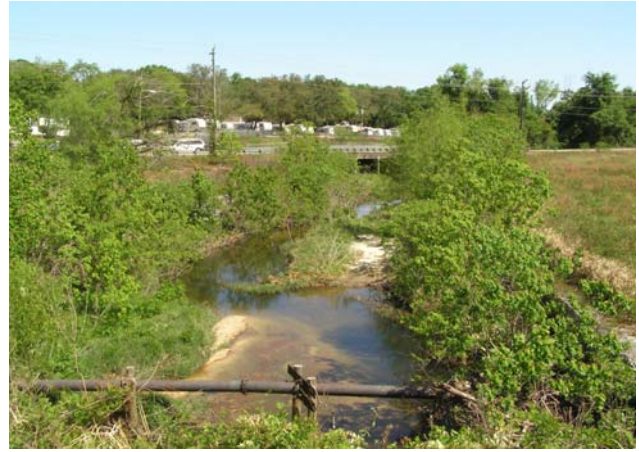
Figure 3 During and after construction looking downstream from section two.

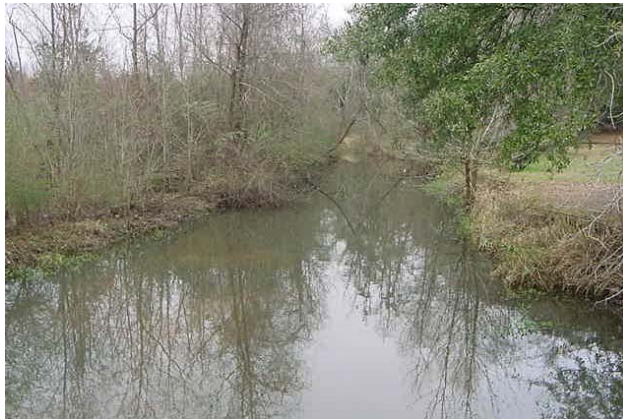
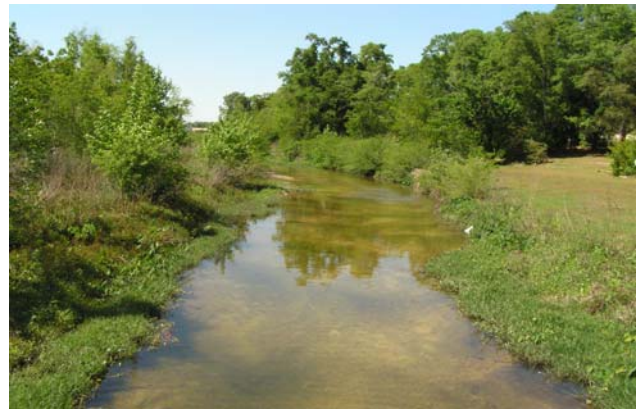
Figure 4 Before and after construction looking upstream from section three.
