CHANGES IN STREAM FLOW WITHIN A LINEAR CHANNEL

Robert M. Johnson, Department of Earth Sciences Student, University of South Alabama, Mobile, AL 36688. E-mail: rmj702@jagmail.southalabama.edu.

In this study, I ask if there is significant change in water velocity within one channelized drainage ditch when the surface type and/or cross sectional area of that ditch changes. Answering this question will be accomplished by attaining the water velocity along the banks and in the middle of the ditch, to provide data on how the surface of the ditch and its general construction allows water to flow through it. The ditch studied is man-made, linear, shallow in slope, and contains equal lengths of altering surfaces such as smoothed concrete, riprap, gabions, and natural vegetation. Water velocity was seen to increase most closely correlated with the width and/or area of the channel, however an increase in stream flow suggests velocity measurements were altered by water being added between sections of channel. This particular ditch is a tributary of Woodcock Creek, and is located within a residential neighborhood near midtown Mobile, AL. Cross sections of the channel will also be taken to pro

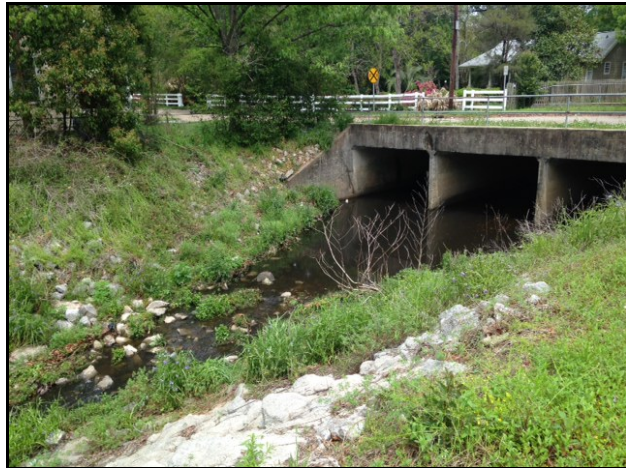
Figure 3. Transition from concrete to riprap channel

Water continues downstream from the smoothed concrete channel and transitions to a well vegetated section armored with riprap. These rocks lined each bank, and had a wide variety of plants growing from the top of the ditch down to the water line. The floor of the channel had some large rocks like those located along the banks, but was predominately covered by smaller stones or the natural stream bed. The total width of ditch at water level was 15ft 1.5in, which is less than half of the width of the ditch several feet upstream (Fig. 3). Due to this section being drastically narrower than the concrete channel upstream from it, the average depth increased to 21.67in. Along with the increase in depth, both the velocity and cross sectional area experienced an increase. Water velocity measured was .11fps and cross sectional area at 27.08ft². The total stream flow, or discharge, for this section was 2.98 cubic feet per second.

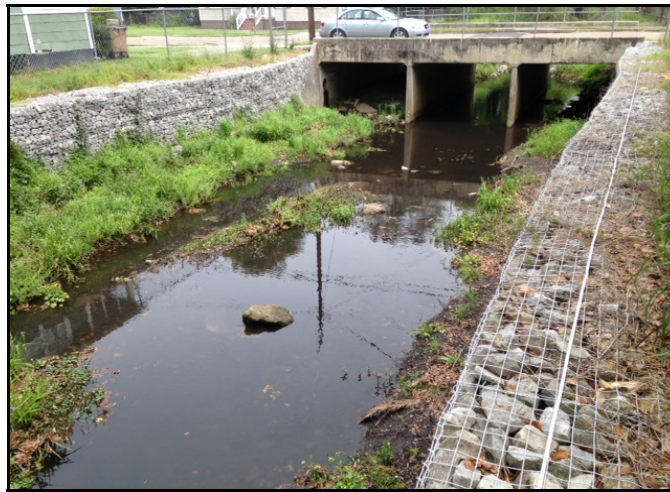
Figure 4. Gabion channel

After flowing through two sections of vegetated riprap channels, the water flow experiences another change when it is greeted by a gabion channel. Although gabions are usually terraced, this channel was constructed with vertical walls two baskets high. The lowest (and third) basket was wider than the two above it but only half as tall, and served

as a foundation for the walls above. The floor of this section seemed to be closer to natural than constructed. Each bank had several feet of soil and vegetation between the gabion walls and the water, which allowed for the water to meander and flow in a more natural fashion than in the previous types of channels (Fig. 4). Although the total width of the channel from one gabion wall to the other was 34ft 6in, the width of the stream at water level was only 21ft 1in. The cross sectional area of the stream was 11.79ft^2 , which is nearly half the area of the concrete section, and almost one third the area of the riprap section. Average depth for this section was 6.74in. The gabion section decreased in area, but velocity and discharge increased substantially. Velocity was recorded at .28fps, and this section of the channel discharged water at a rate of 3.3 cubic feet per second.
